Studying the Seismic Behavior of Cross Laminated Timber

Joycelyn Ng

University of California, San Diego – Large High Performance Outdoor Shake
Table

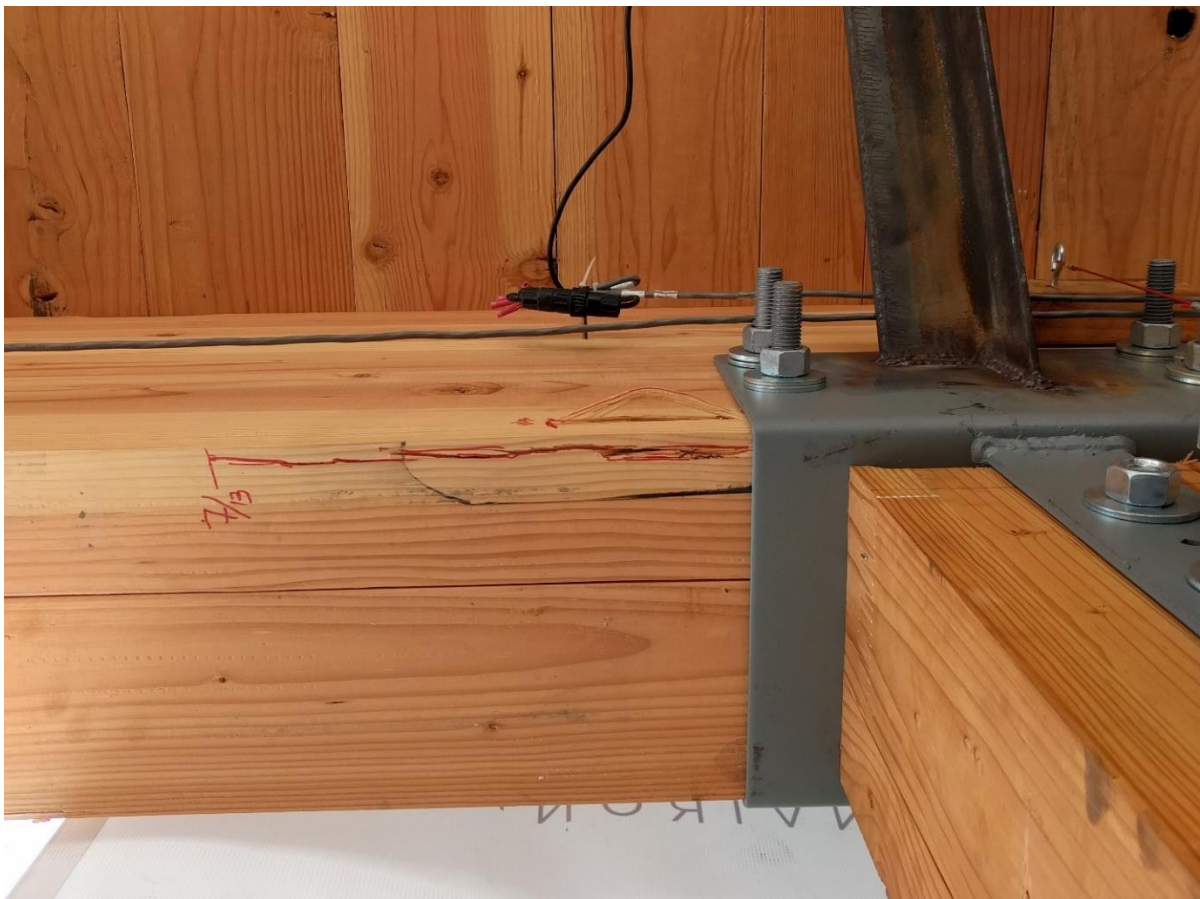
The 1994 Northridge test at 125% strength was conducted on the CLT structure at the shake table. Only minor damage and no major structural damage was found on the structure. Small cracks and splitting of the timber's grains were found near the connections of the beam and columns (figures 3, 4, and 5)

Figure 3. Crack and small splitting at a beam located on the NE section of the second floor
(looking from ground up)

From this test, it can be noted that damage typically occurred near the connections and joints of the structural members. As the walls rock about their corners, the structure experiences uplift and shear. Such effects caused damages in the columns, beams, and the walls of the structure. The crack shown in figure 2 is due to flexure in the beam since the damage is perpendicular to the grain. The wood splitting in the columns in figures 2 and 4 may be a result of crushing in the members. Such results reflect the conclusions that Pei found in researching CLT in that uplift during earthquakes can cause severe damage to connections (6). Despite such damages, these are merely surface damage and do not threaten the structural integrity of the CLT building at all.

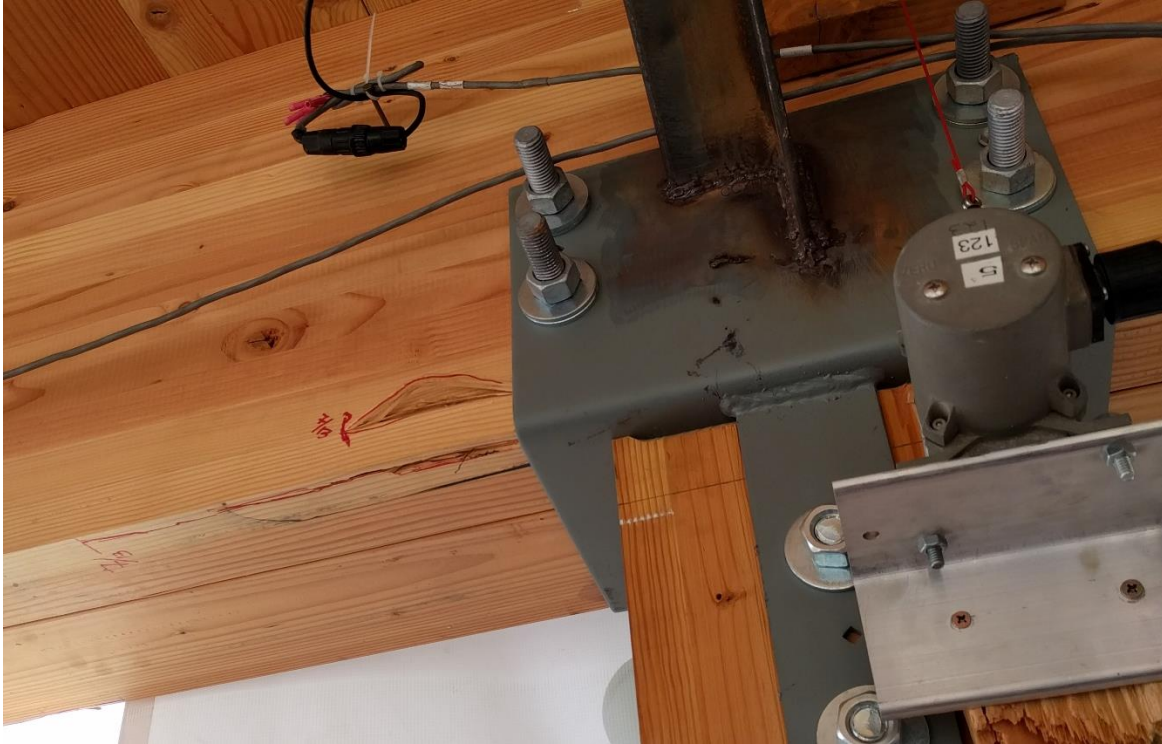
Figure 4. Small splinter of the beam near the connection (Same damage documented in figure 2)

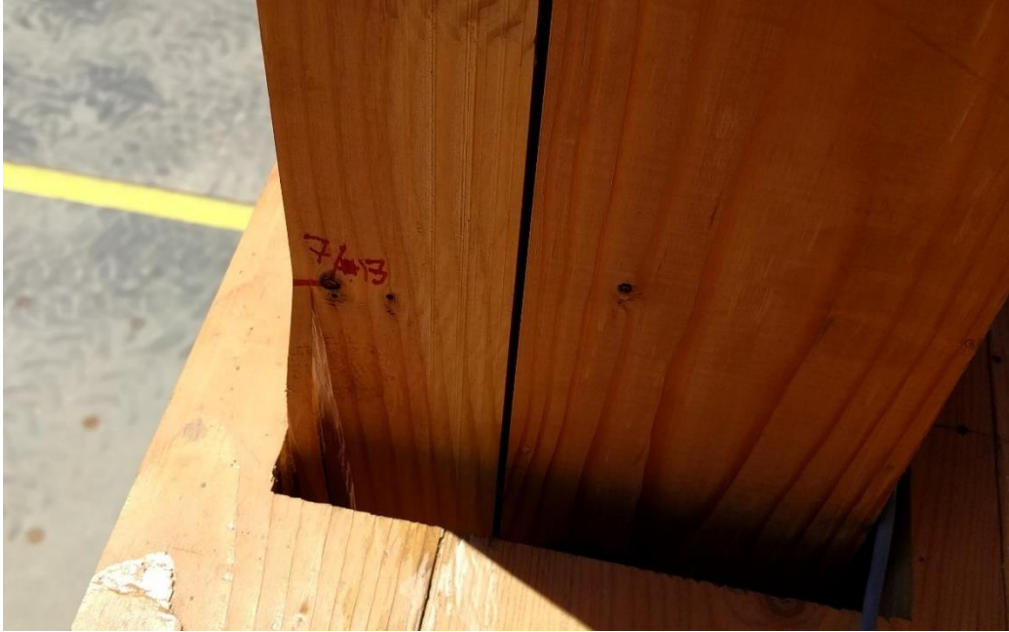
Some crushing was found at the bottom corners of the rocking walls (less than an inch). Other damages due to crushing on the walls ranged from 3 to 5 inches (figure 6). Minor rounding of the corners was seen at the foot of the columns and the rocking walls (less than half of an inch). Small separation of about 1 to 3 millimeters between the CLT pieces was found on the walls and columns (Figure 5). Majority of the damage on the CLT was found on the second floor rather than the ground floor.

Figure 5. Wood splinter at the bottom of the discontinuous column and separation of the lamination located at the NW section of the second floor

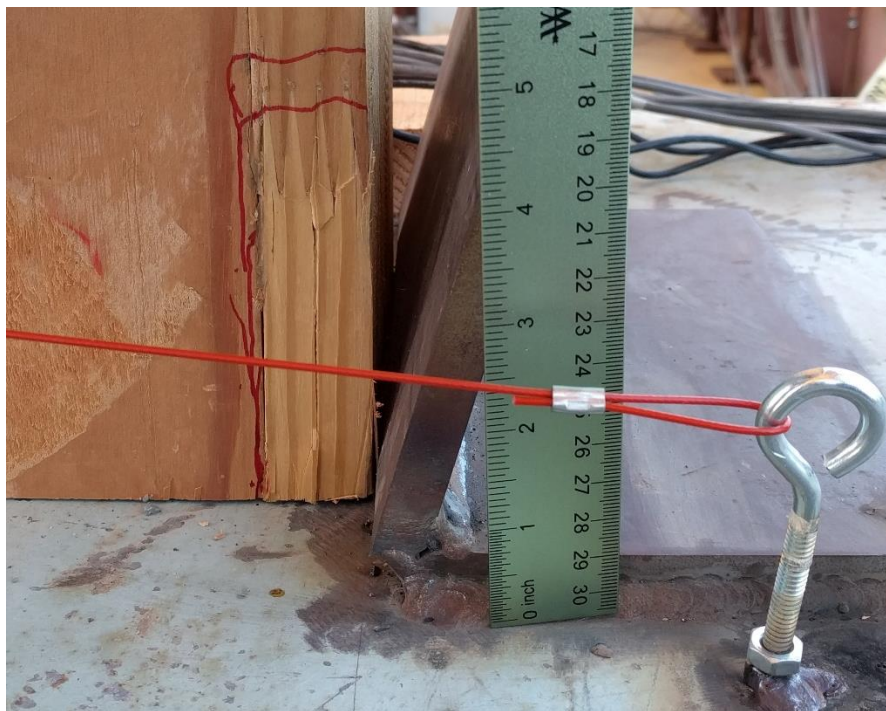
Figure 6. Toe crushing found at the foot of the rocking wall (north face of the NW panel)

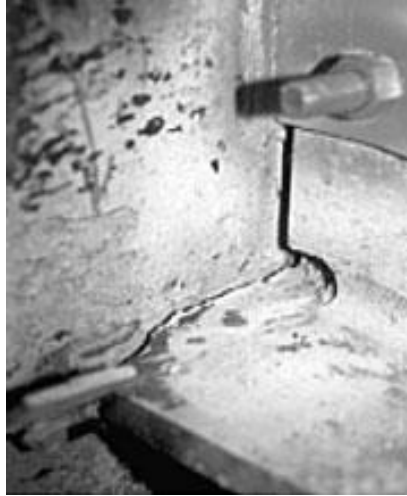
To conduct a comparison, damage due to the 1994 Northridge earthquake in steel and concrete structures will be observed. After the Northridge earthquake, steel moment frames didn't show signs of plastic deformation, but suffered from damage. Since the late 1960s, welded flange connections were used more commonly than bolted flange connections. After the Northridge earthquake, such a connection is no longer used since most of the damage caused by this earthquake can be mainly attributed to cracking at the bottom beam flange weld, as shown in figure 7 (Nakashima, Roeder, Maruoka 861).

Figure 7. Weld cracking at the bottom of the flange

Beams under flexural loads result in a tensile force on the welds on the bottom of the flange, which is the cause of the cracking. Aside from weld cracking, column cracking and beam flange cracking also occurred. The damage was typically concentrated amongst new buildings with deeper and heavier beams (Nakashima, Roeder, Maruoka 861-862). This is problematic due to the fact that such beams were designed this way because they were at critical locations of the structure. Similarly, the cracks were found at the bottom side of the beam and the foot of the columns. This type of damage was expected due to similar load paths, however the damage in the CLT members weren't as detrimental to the structure.

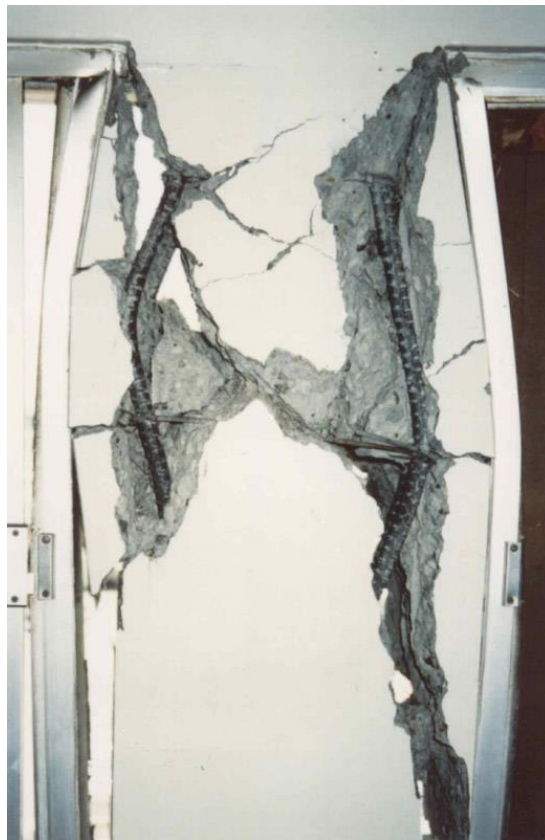
members fail. Reports found that columns typically failed due to shear failure (figure 8). They also stated failure in gravity columns when paired with ductile members, such as moment resisting frames. Inelastic deformation will happen in the lesser ductile member, which in this case is the gravity column. Gravity columns are meant to only carry “gravity” loads, so it is detrimental when they are used inappropriately for resisting moments. The above results caused shear and tension cracks in the concrete structures.

Figure 8. Shear failure and buckling of column
