Studying the Seismic Behavior of Cross Laminated Timber

Joycelyn Ng

University of California, San Diego – Large High Performance Outdoor Shake
Table

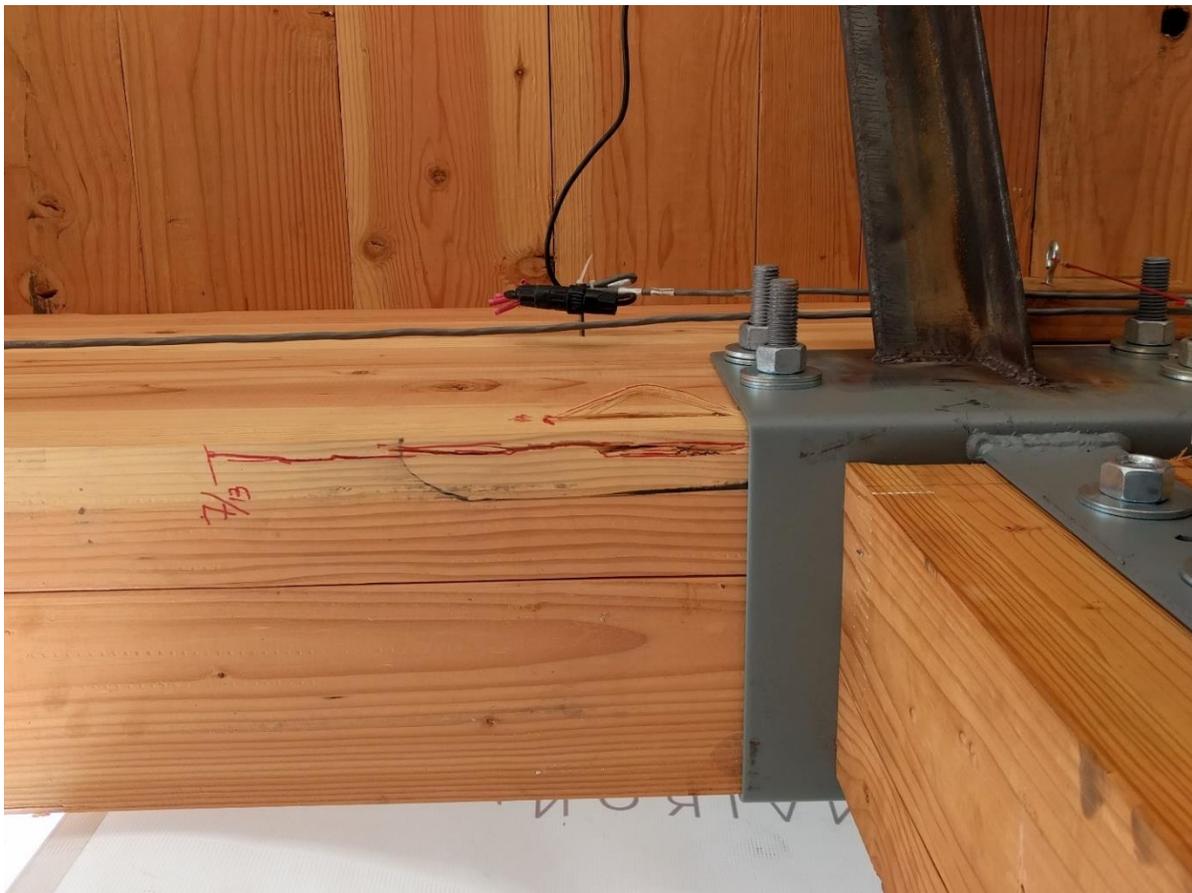
The 1994 Northridge test at 125% strength was conducted on the CLT structure at the shake table. Only minor damage and no major structural damage was found on the structure. Small cracks and splitting of the timber's grains were found near the connections of the beam and columns (figures 3, 4, and 5)

Figure 3. Crack and small splitting at a beam located on the NE section of the second floor
(looking from ground up)

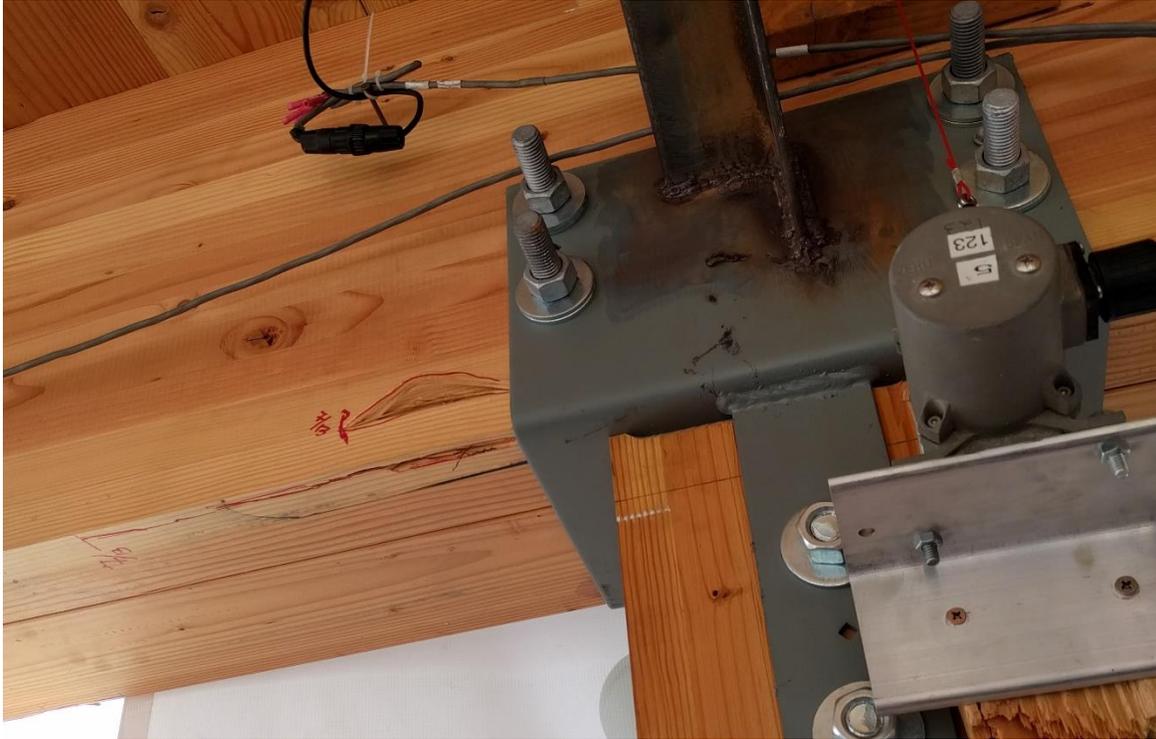
Figure 4. Small splinter of the beam near the connection (Same damage documented in figure 2)

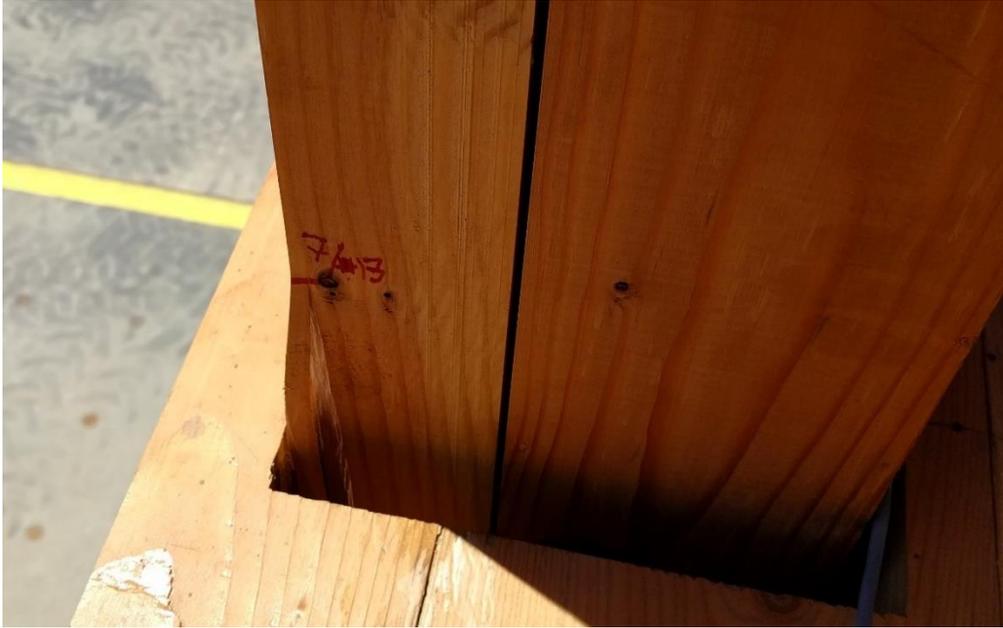
Some crushing was found at the bottom corners of the rocking walls (less than an inch). Other damages due to crushing on the walls ranged from 3 to 5 inches (figure 6). Minor rounding of the corners was seen at the foot of the columns and the rocking walls (less than half of an inch). Small separation of about 1 to 3 millimeters between the CLT pieces was found on the walls and columns (Figure 5). Majority of the damage on the CLT was found on the second floor rather than the ground floor.

Figure 5. Wood splinter at the bottom of the discontinuous column and separation of the lamination located at the NW section of the second floor

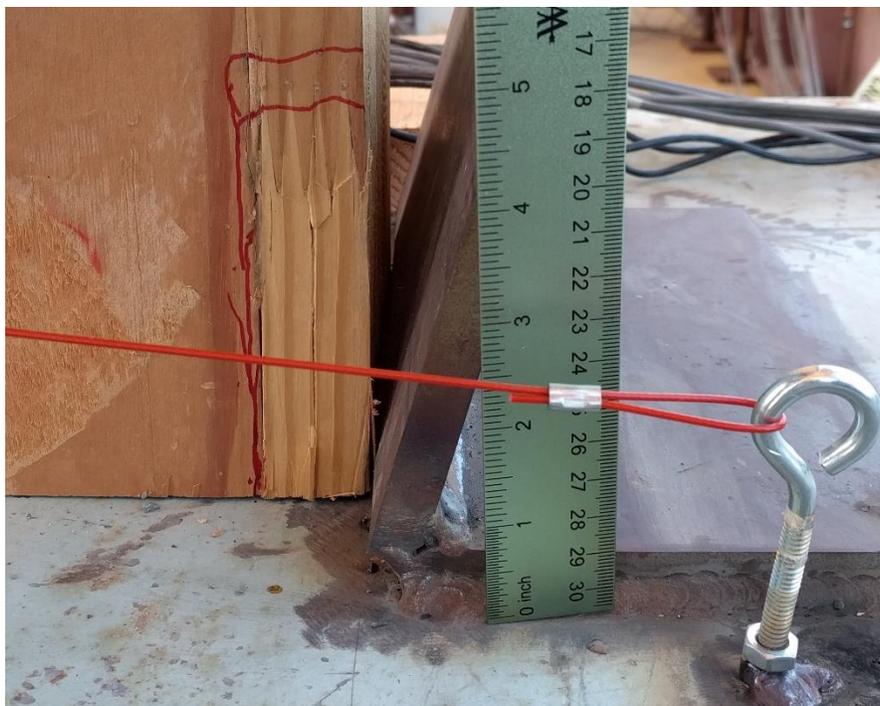
Figure 6. Toe crushing found at the foot of the rocking wall (north face of the NW panel)

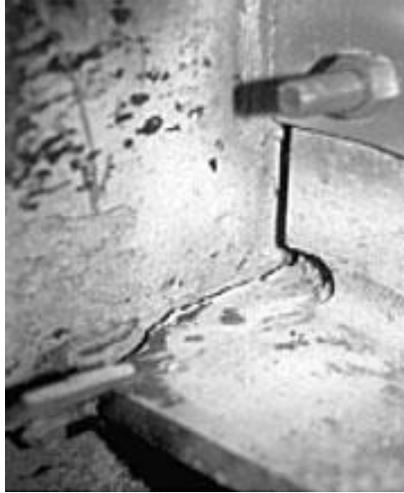
To conduct a comparison, damage due to the 1994 Northridge earthquake in steel and concrete structures will be observed. After the Northridge earthquake, steel moment frames didn't show signs of plastic deformation, but suffered from damage. Since the late 1960s, welded flange connections were used more commonly than bolted flange connections. After the Northridge earthquake, such a connection is no longer used since most of the damage caused by this earthquake can be mainly attributed to cracking at the bottom beam flange weld, as shown in figure 7 (Nakashima, Roeder, Maruoka 861).

Figure 7. Weld cracking at the bottom of the flange

Beams under flexural loads result in a tensile force on the welds on the bottom of the flange, which is the cause of the cracking. Aside from weld cracking, column cracking and beam flange cracking also occurred. The damage was typically concentrated amongst new buildings with deeper and heavier beams (Nakashima, Roeder, Maruoka 861-862). This is problematic due to the fact that such beams were designed this way because they were at critical locations of the structure. Similarly, the cracks were found at the bottom side of the beam and the foot of the columns. This type of damage was expected due to similar load paths, however the damage in the CLT members weren't as detrimental to the structure.

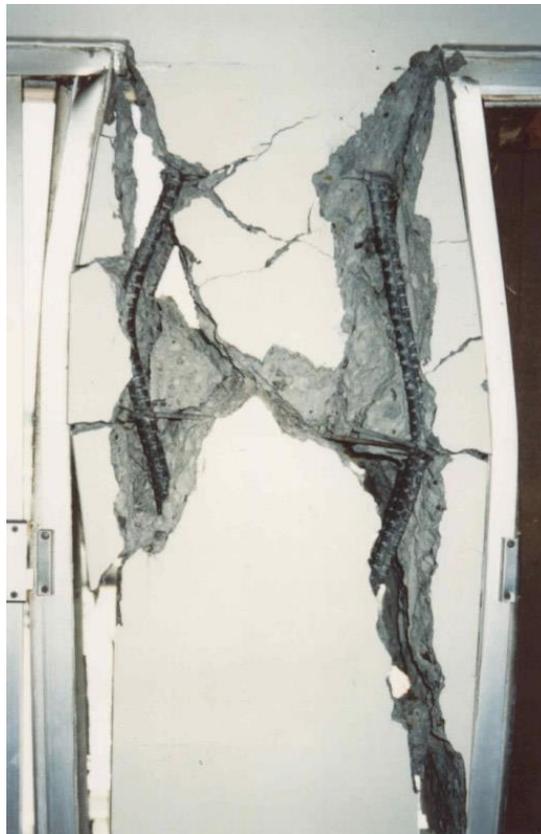
members fail. Reports found that columns typically failed due to shear failure (figure 8). They also stated failure in gravity columns when paired with ductile members, such as moment resisting frames. Inelastic deformation will happen in the lesser ductile member, which in this case is the gravity column. Gravity columns are meant to only carry “gravity” loads, so it is detrimental when they are used inappropriately for resisting moments. The above results caused shear and tension cracks in the concrete structures.

Figure 8. Shear failure and buckling of column
