Stress-Strain Properties of Cross Laminated Timber in Compression

Zachary R. Duskin

Lehigh University

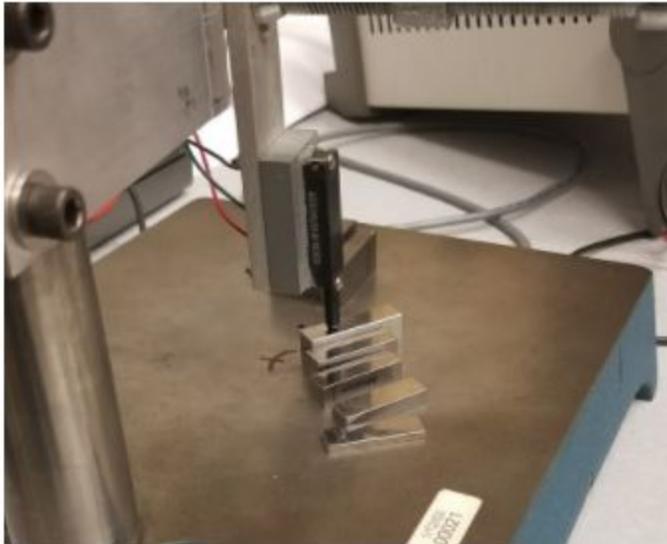
Figure 3: Potentiometer during calibration, with plunger compressed with gauge block

then compressed using gauge blocks, as shown in Fig.3, and the amount of voltage reduction was recorded. A coefficient corresponding to the ratio of inward motion of the plunger vs. voltage loss for each potentiometer was created using linear regression. The deflection measured by the potentiometers during testing could then be determined by multiplying the coefficient with the

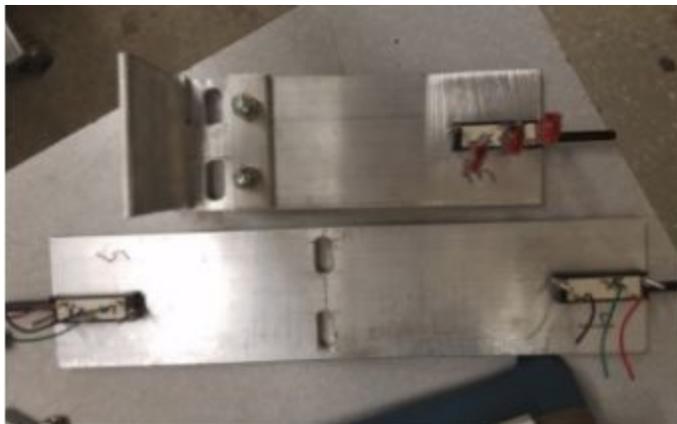
Figure 4: Potentiometers mounted onto aluminium plates.

The potentiometers were attached to aluminium plates, shown in Fig.4, which were then mounted onto the specimen.

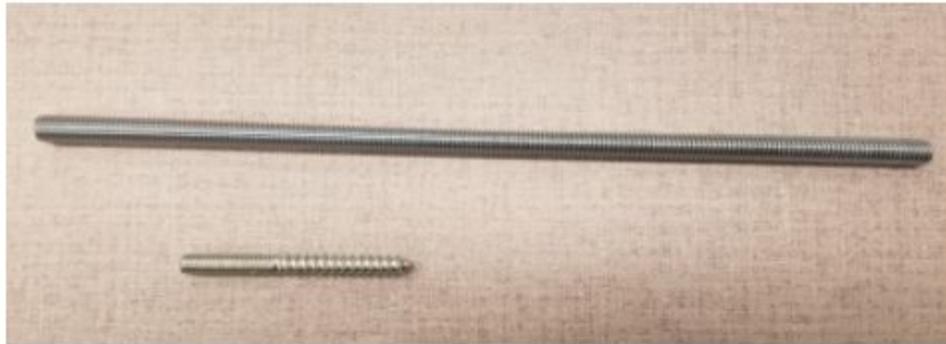
Figure 5: Threaded rods used on specimen 1 (top)
and screws used for specimen 2-5 (bottom).

The potentiometers were arranged to measure the deflection of the specimen along its height at three equal length of 6.875". Strain gauges were epoxied to the center of each face of the specimen to measure the strain in the elastic response region. The aluminium plates were mounted on specimen 1 with $\frac{1}{4}$ " threaded rods (shown in Fig.5) that were drilled

through the entire thickness of the specimen. The plates were mounted on specimens 2, 3, 4, and 5 using $\frac{1}{4}$ " screws (shown in Fig.5). Each screw penetrated $1\frac{1}{2}$ " into the specimen.

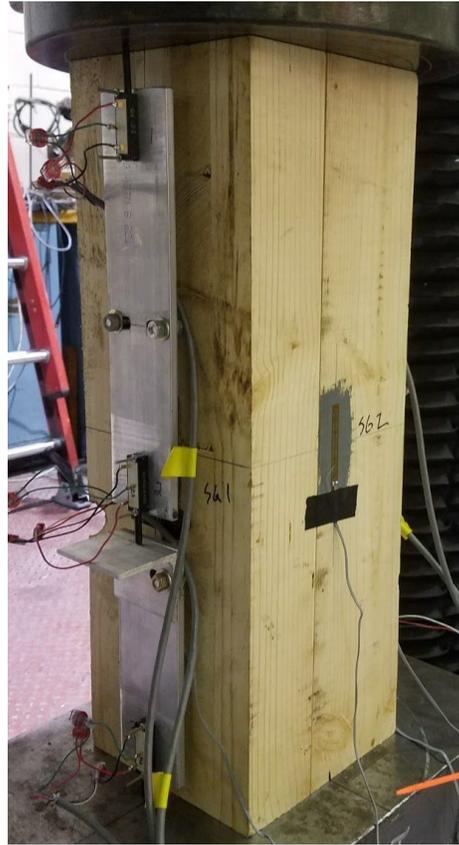
Figure 7b: Aluminium plate and potentiometer set-up for specimens 2-5.

Figure 6a shows an illustration of the setup of specimen 1, while Fig.6b shows an illustration of specimens 2, 3, 4, and 5. Figures 7a and 7b show the plate and potentiometer set-up on an actual specimen. The plates and potentiometers were placed on the unmilled sides of specimen 1 (shown in Fig. 7a) while the plates and potentiometers were placed on the milled sides of specimen 2 through 5 (shown in Fig.7b).

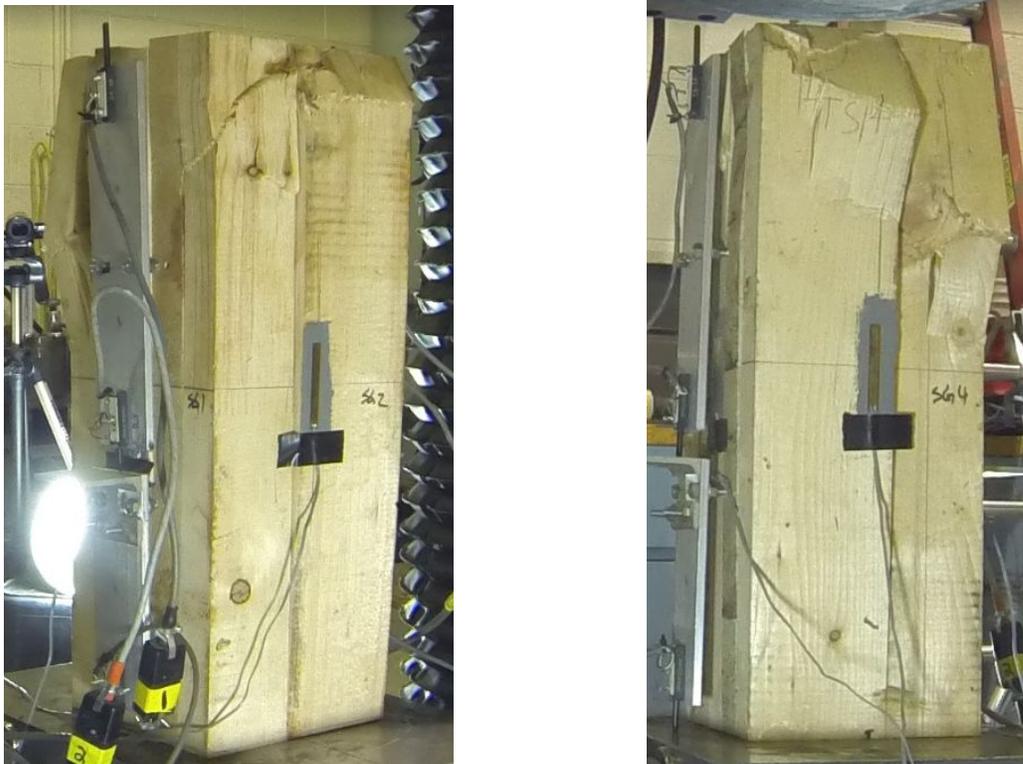
Specimen 4 failed in the upper gauge length, shown in Fig.19. Several holes about 1mm in diameter were found the unmilled sides of specimen 4 before testing. Specimen damage occurred along the small holes.

Figure 19: Specimen 4 failure

The failure pattern of specimen 4 was due to a defect in the specimen. Several small holes approximately 1mm in diameter were found on the unmilled sides of specimen 4. Cracks formed running through the holes, suggesting that the specimen may have failed prematurely because of them. Also, one of the potentiometers on specimen 4 was not in contact with the surface of the crosshead, and so the potentiometer's deformation data is not completely accurate.

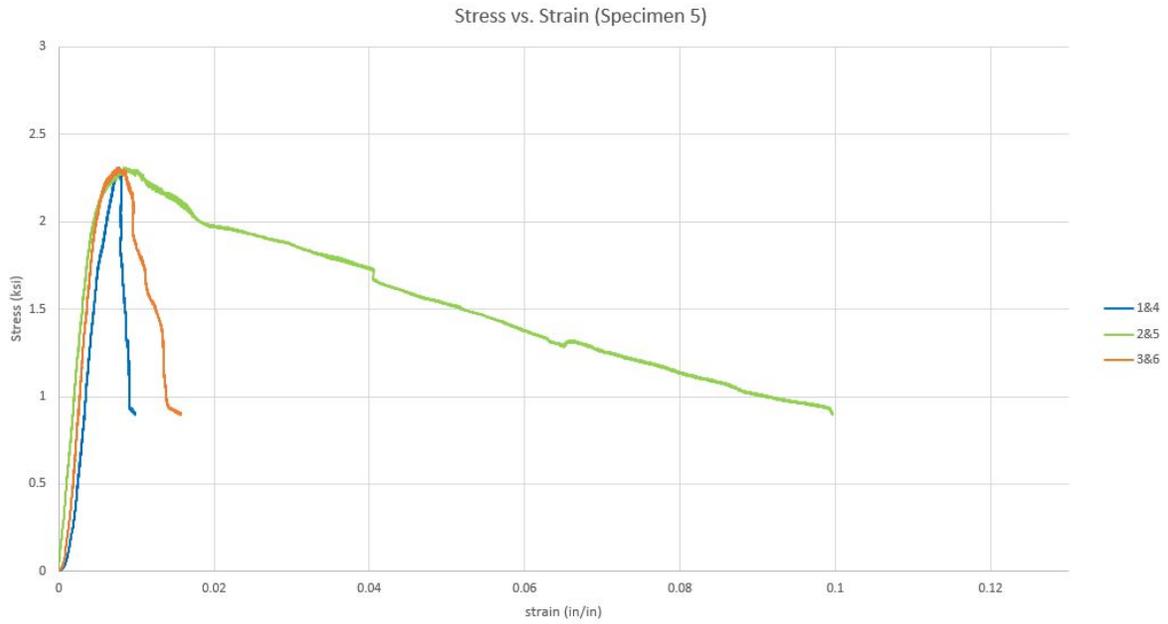
Figure 25: Stress-strain response of specimen 5, according to potentiometers.

Figures 24 and 25 show the stress-strain response of the strain gauges and the potentiometers for specimen 4, respectively. Figure 26 shows the force-displacement plot for specimen 4.
